cranedge

The Case Of The **Snapped Rope**

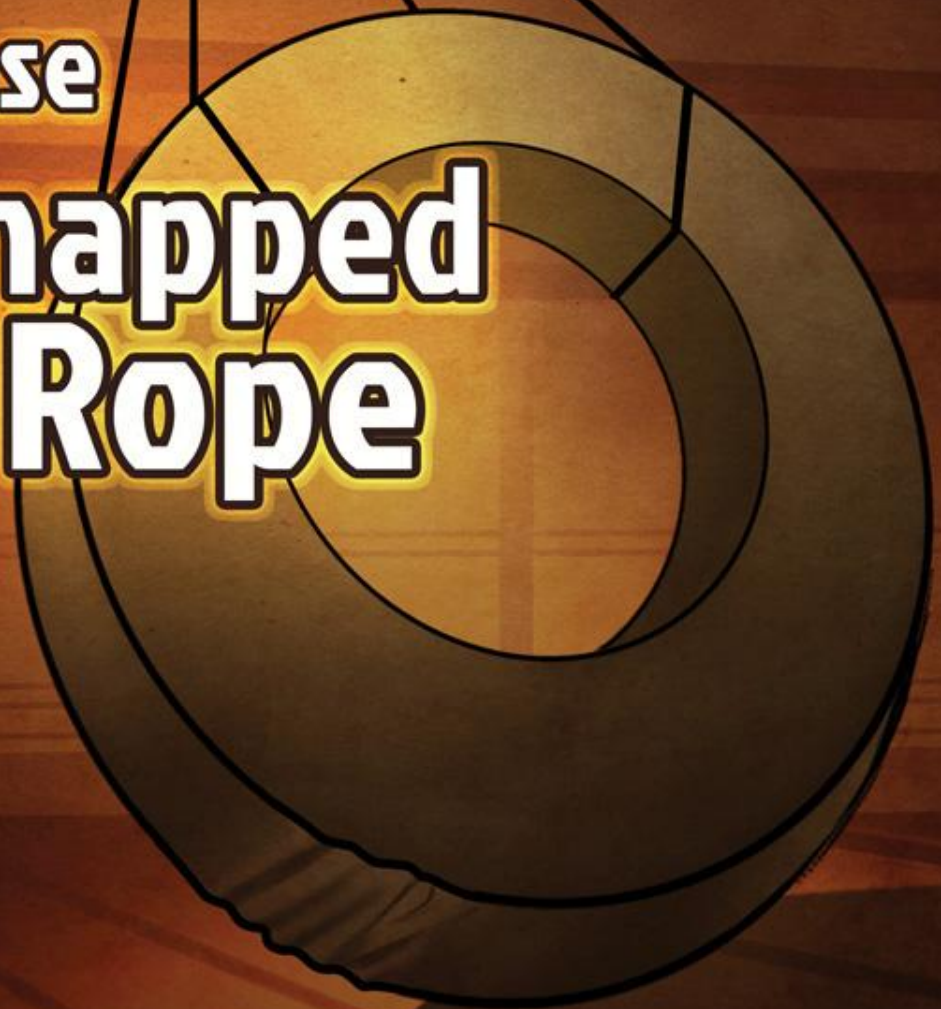
THE WIRE ROPE IS FRAYED IN MULTIPLE PLACES AND HAS SNAPPED, CAUSING THE ACCIDENT.

THE STEEL COIL THAT THE CRANE WAS CARRYING IS SEVERELY DAMAGED.

THE ROPE GUIDE IS BROKEN.

SIR, WE PERFORMED A DETAILED FAILURE ANALYSIS WHICH CONCLUDED THAT THE STEEL COIL WAS BEING CROSS PULLED.

DUE TO CROSS PULLING, THE ANGLE OF LIFTING DEVIATED FROM THE VERTICAL AND THIS REDUCED THE RATED CAPACITY OF THE WIRE ROPE. MOREOVER, THE WIRE ROPE JUMPED OUT OF THE ROPE DRUM GROOVES AND GOT ENTANGLED. THIS ALSO LED TO JAMMING OF THE ROPE GUIDE.

REPETITIVE OCCURRENCES LED TO ULTIMATE FAILURE OF THE WIRE ROPE DUE TO ITS UNWARRANTED WEAR AND TEAR. THIS ALSO LED TO BREAKING OF THE ROPE GUIDE.

SIR, WE HAVE REPLACED THE WIRE ROPE AND ROPE GUIDE. WE HAVE RESTORED THE CRANE AND CONDUCTED TESTS TO ASCERTAIN SMOOTH OPERATION OF YOUR CRANES. THE RELEVANT REPORTS ARE ON YOUR TABLE!

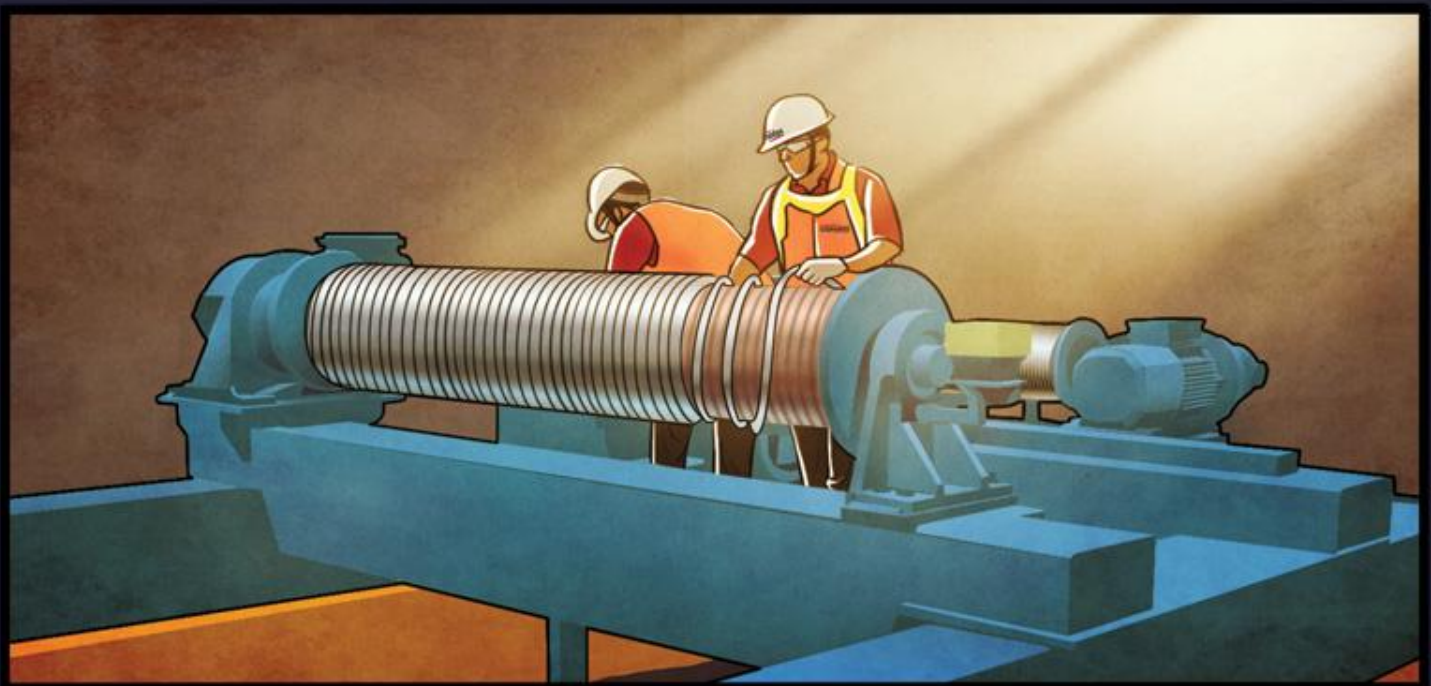
CRANEDGE TEAM AT WORK

WHEN THE OPERATOR WAS TRYING TO LIFT THE STEEL COIL, HE DIDN'T POSITION THE CRANE EXACTLY OVER THE STEEL COIL, BUT AT A CERTAIN DISTANCE AWAY FROM THE COIL.

AFTER SLINGING, AS THE HOISTING MOTION COMMENCED, THE LOAD COIL WAS BEING PULLED AND LIFTED AT THE SAME TIME. THIS IS WHAT TYPICALLY HAPPENS DURING CROSS PULLING. IDEALLY THE LOAD HAS TO BE ALWAYS LIFTED VERTICALLY.

FURTHERMORE, CROSS PULLING DRAGGED YOUR COIL ON THE SHOP FLOOR AND THIS DAMAGED NOT ONLY YOUR COIL BUT ALSO YOUR FLOOR.

DURING SUCH WRONG PRACTICE, THERE IS AN INHERENT THREAT OF THE LOAD SWINGING HAZARDOUSLY ONCE IT IS OFF THE GROUND, AS THE LIFTING IS AT AN ANGLE. YOUR COMPANY HAD A NARROW MISS IN THIS REGARDS, AS A SWINGING LOAD CAN LEAD TO SERIOUS ACCIDENTS.
